# The AGORA

Adapted mixed-use development

The project is an adaptation of the adaptation of an abandoned industrial plant in Kikuyu town, Kiambu county - Optimum Oil and Lubricant Factory.

B.ARCH VI 2025

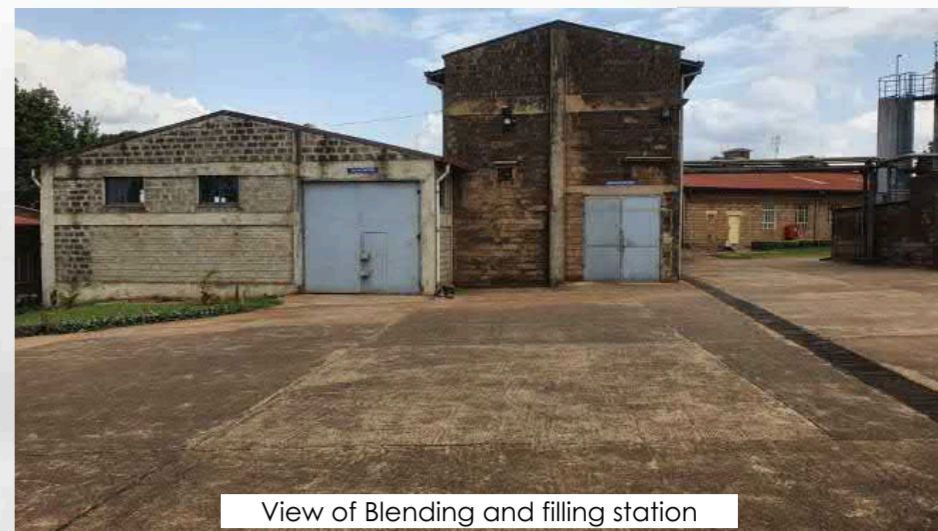
View of Blending and filling station

SPACE	GRAPHIC/VISUAL	CONDITION ANALYSIS
Filling station (Later addition) 2010 23x14m 6m H.R - 2 floors (Gable-Pitch roof) H = 7m		<b>CONDITION - GOOD</b> - Intact structure - Unfinished walls - Doors, roof and window frames in good condition - Most window panes intact - Newer addition
Filtration tower (Later addition) 2010 8x4m 4m H.R - 4 floors (Gable-Pitch roof) H = 13m		<b>CONDITION - GOOD</b> - Intact steel structure - Oil stains - Doors, roof and window frames in good condition - Patchy corrugated sheets at the top - Most window panes intact - Newer addition

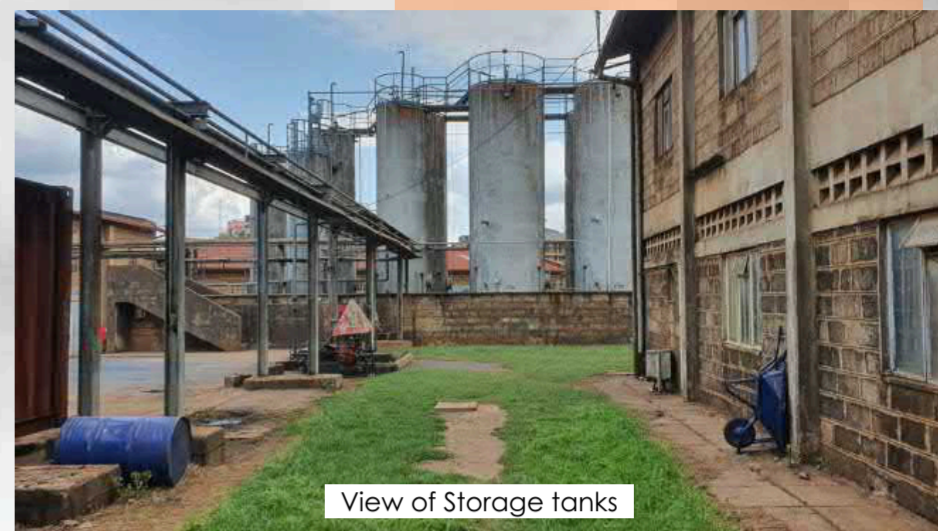
View of Storage tanks

**CONDITION - FAIR**  
- Intact structure  
- Eroded base on overflow pit  
- Patina  
- Flaked paint on tank walls  
- Rusted fastening components

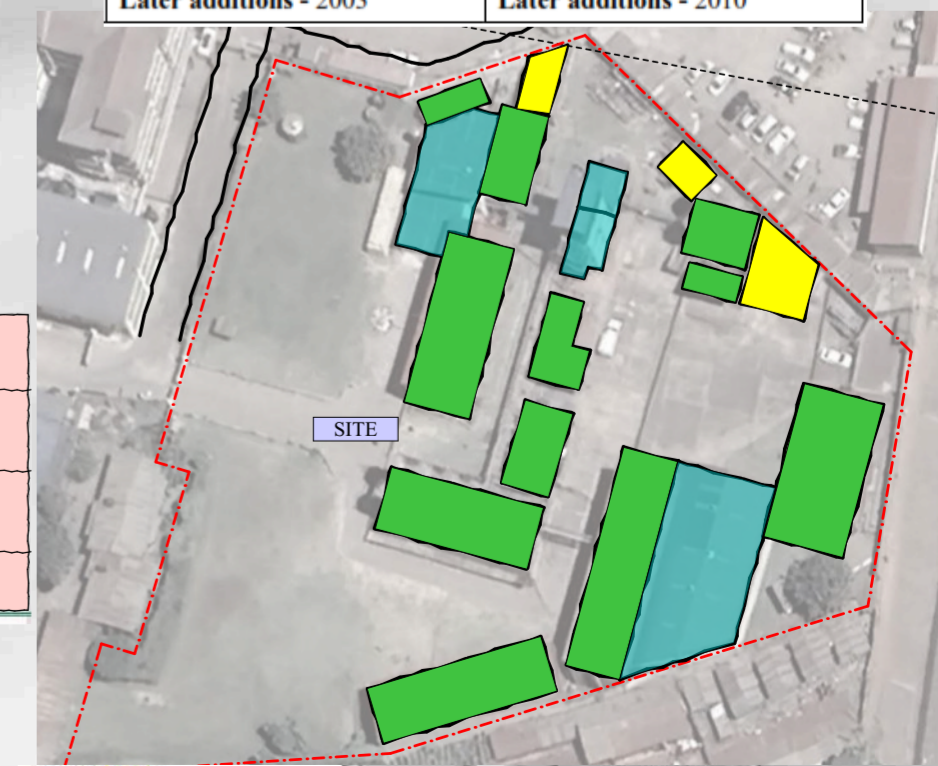
**Building typologies based on condition**

Workshop & laboratory 25x8.5m 3.5m H.R (Pitch roof) H = 5.5m		<b>CONDITION - FAIR</b> - Intact structure - Accrued patina (1980) - Partial corrosion on doors, roof and window frames - Oil stains on floor - Stained glazing - Most window panes intact - Faded paint on walls
Blending station 23x10m 3m H.R (2 floors) H = 10m		<b>CONDITION - FAIR</b> - Intact structure - Accrued patina (1980) - Partial corrosion on doors, roof and window frames - Oil stains on floor - Stained glazing - Most window panes intact - Faded paint on walls
Admin block 10x15m 4m Height (Pitched roof) H = 10m		<b>CONDITION - FAIR</b> - Intact structure - Accrued patina (1980) - Partial corrosion on doors, roof and window frames - Stained glazing - Most window panes intact - Faded paint on walls
Storage & processing near entrance 26x10m 3.5m H.R -2 floors (Gable Pitch roof) H = 9m		<b>CONDITION - FAIR</b> - Intact structure - Accrued patina (1980) - Partial corrosion on doors, roof and window frames - Stained glazing - Most window panes intact - Faded paint on walls
